# Airborne Instrumentation System for Measuring Meteorological Phenomena Inside Thunderstorms

TECHNICAL DOCUMENTARY REPORT NO. ASD-TDR-63-231

May 1963

Directorate of Flight Test  
Aeronautical Systems Division  
Air Force Systems Command  
Wright-Patterson Air Force Base, Ohio

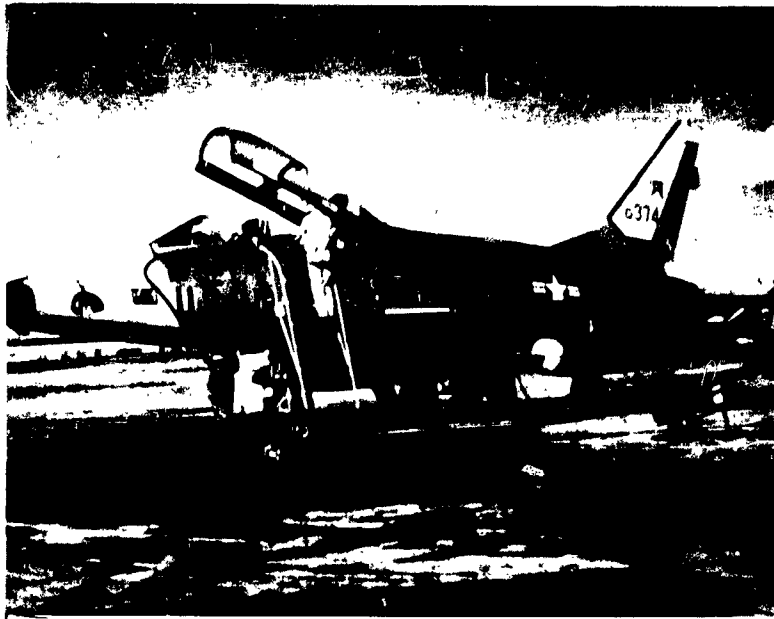
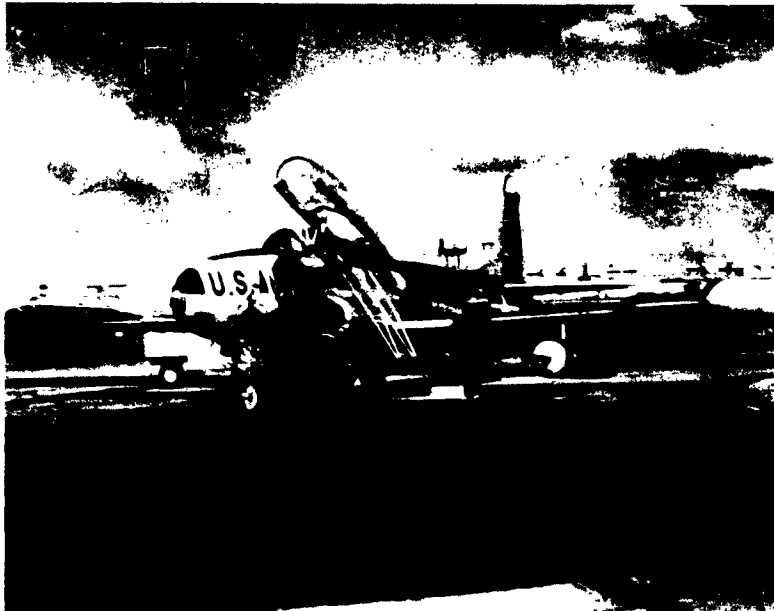
Figure 1. F-100 and T-33 Test Aircraft

The test aircraft, F-100F, S/N 56 - 3744, and T-33, S/N 53 - 5404, were essentially in standard configuration except as described herein. The F-100 (figure 1) carried instrumentation in both gun bays, both expended link bays, several electronics bays, and the forward nose compartment. The cloud particle camera was mounted in a modified external fuel tank. The nose boom was fitted with wind-direction vanes. Numerous static dischargers of a new design were mounted on the wings and empennage. The engine was equipped with pilot-selected continuous ignition.

The T-33 (figure 1) carried instrumentation in the rear cockpit in place of the seat. A nose boom for wind-direction vanes was mounted in one of the gun ports. The cloud particle camera was installed in a modified chaff dispenser under the left wing.

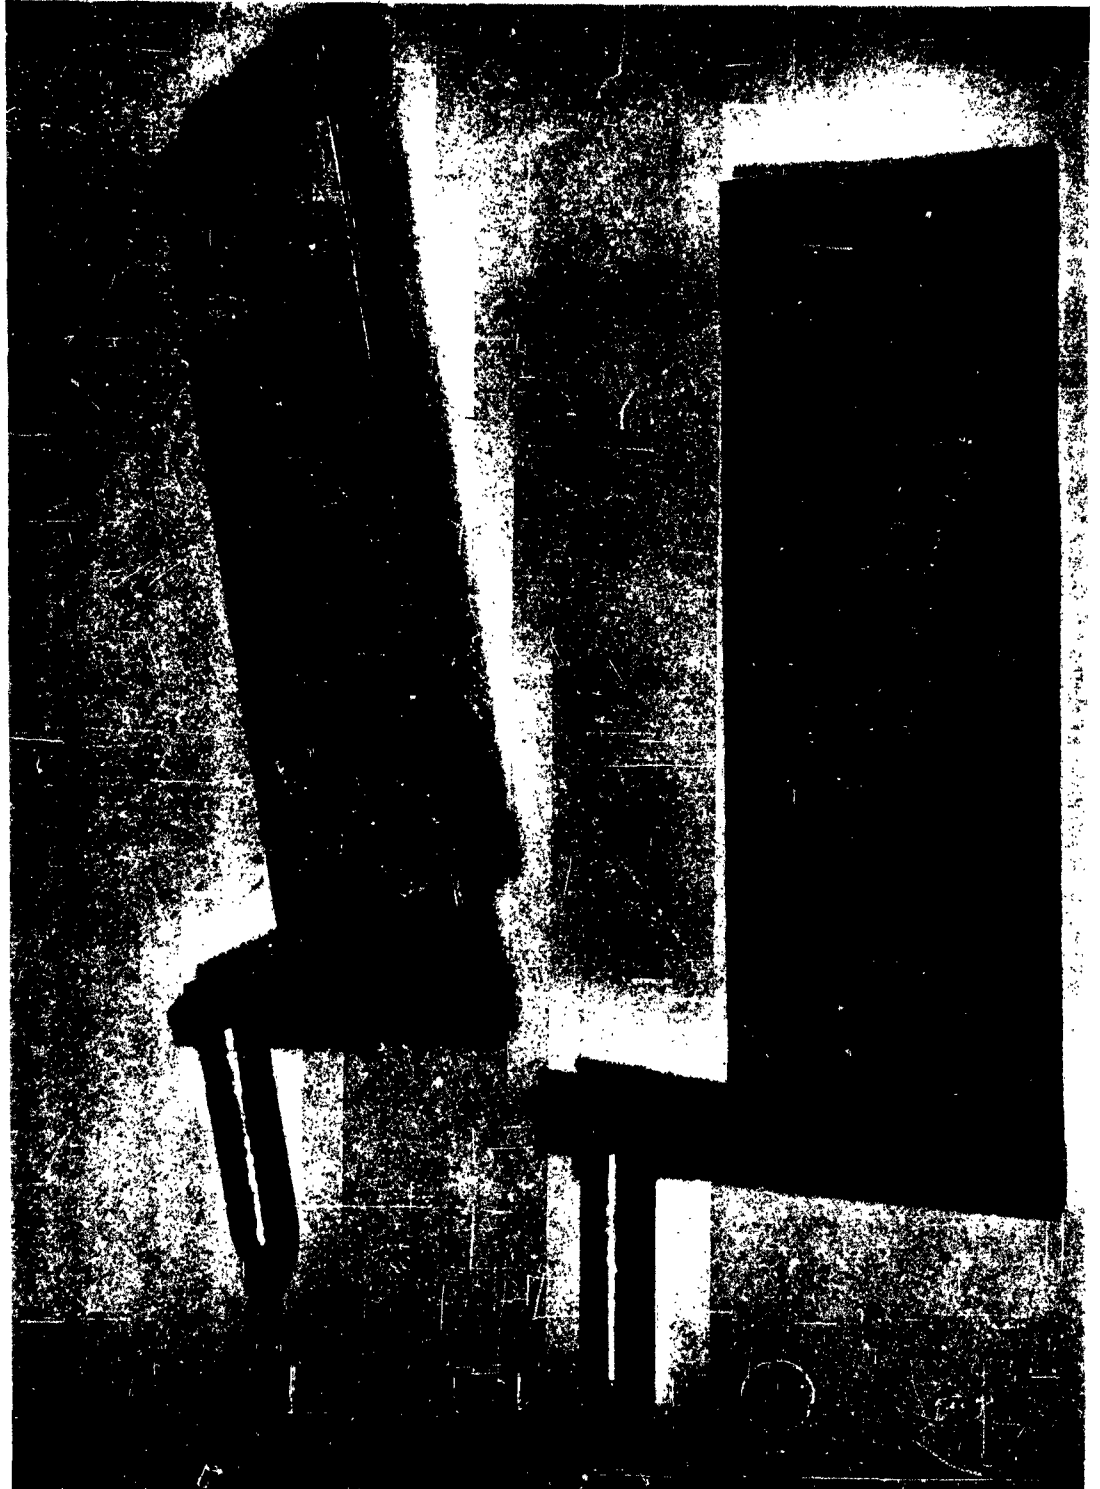
Figure 3. New Plywood Gust Vanes

The vanes were constructed of 1/16 inch thick plywood (figure 3) to provide ruggedness in the hail/precipitation environment. Balsa wood vanes used in the 1960 and 1961 thunderstorm projects were unsatisfactory from a structural standpoint, even though they had excellent response characteristics. A degradation in performance was accepted as the price for vanes which would remain intact through the worst storms.

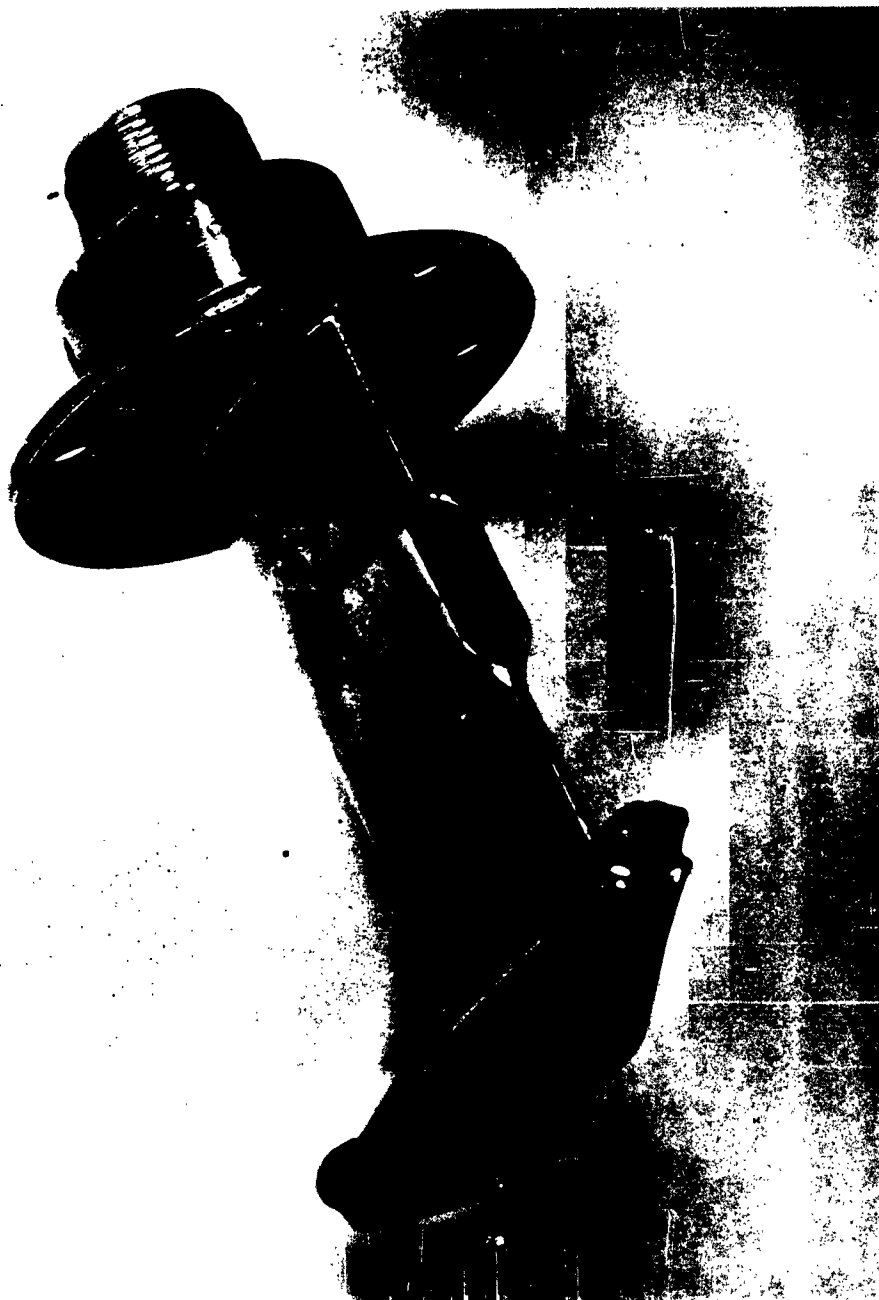
Figure 5. Rosemount Total Temperature Probe

Indicated temperature was sensed with a Rosemount total temperature probe mounted on the forward bottom portion of the fuselage (figure 5). An open wire element was used initially in the T-33. A hermetically sealed element was used throughout the program on the F-100. Heavy icing conditions encountered on one penetration caused the element wire in the T-33 probe to break. Therefore, only sealed elements should be used in this type of flight test program.

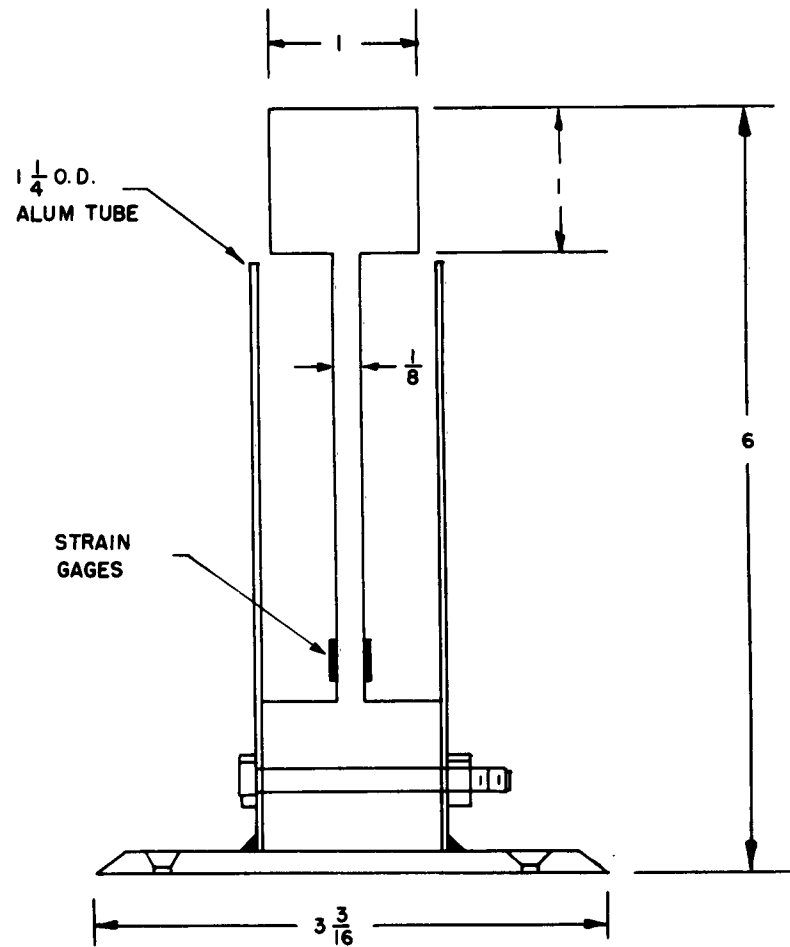
Figure 7. Dimensional Sketch of Hail Mass Probe

A device to detect impacts of hail and, hopefully, to measure its mass was fabricated as shown in figure 6 (shield slightly damaged). SAE 1045 steel was machined to the shape described in figure 7. Strain gages were mounted near the base of the beam to detect bending strain caused by impacts. The output of the gages was run through a bridge network before being recorded so that only the gage in tension was feeding the galvanometer.

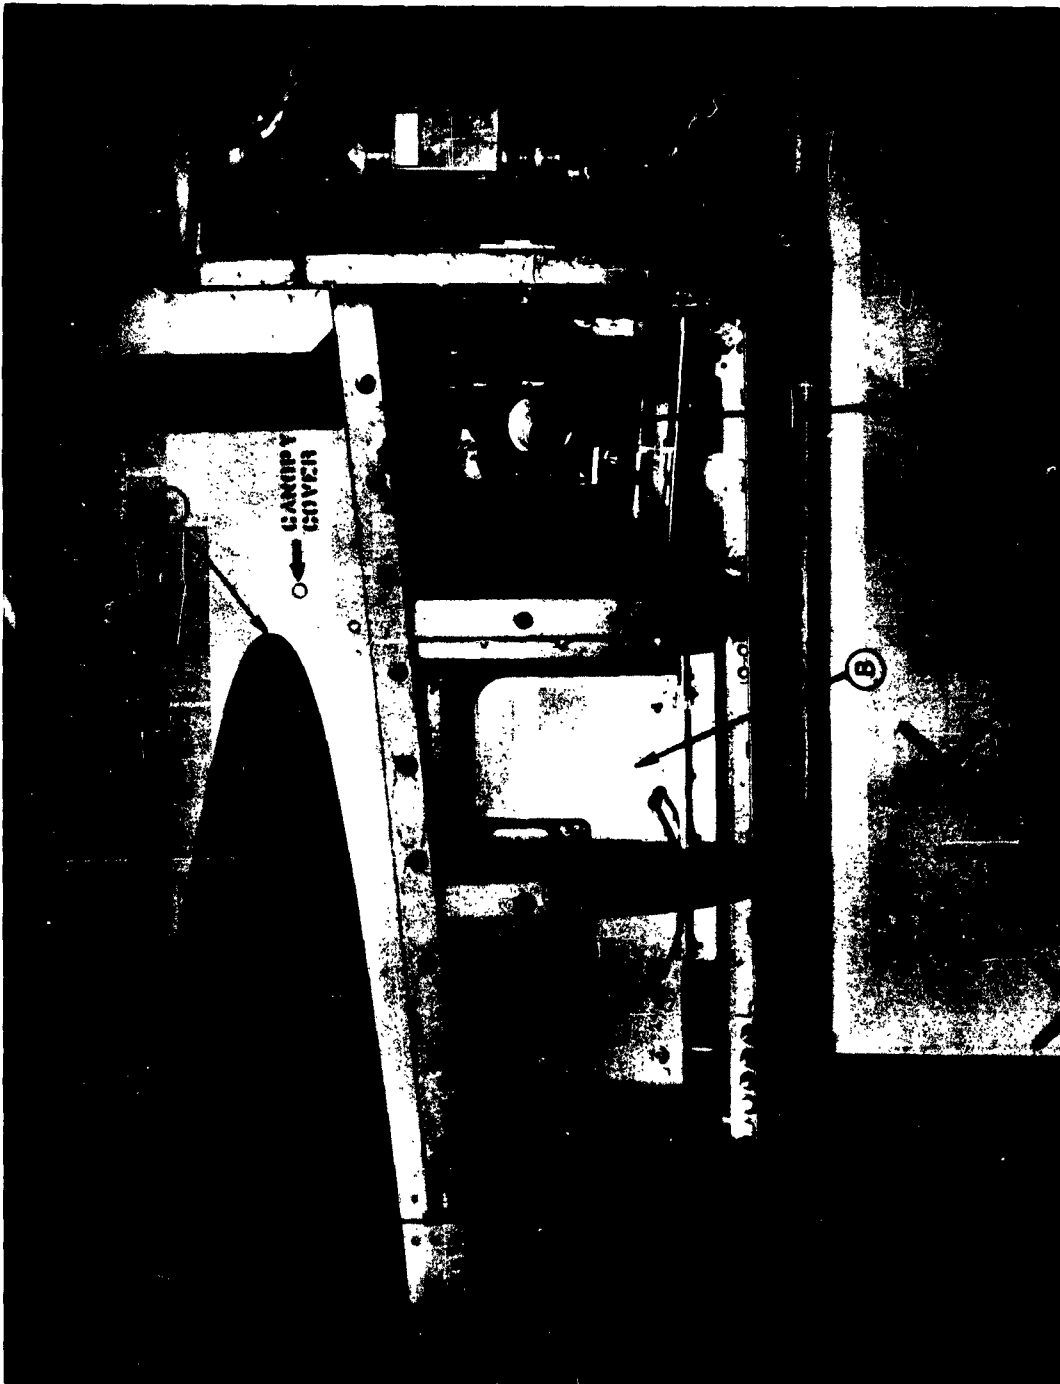
Figure 14. Amplifier for Liquid Water Content Device and Hail Camera Mounted in Fuselage Bay, F-100

A 16mm high-speed movie camera, mounted in the right side of the F-100 fuselage (figure 14, Item C, and figure 21), was focused on the black tip of the right external fuel tank. When hail was encountered the instrument operator turned on the camera. It ran at 2000 frames/second, going through 100 ft of film in about two seconds.

Instrumentation wiring from the fuselage to the left wing was abraded (figure 42) when a gasket at the leading edge of the wing root was worn away (Item A, figure 14). Precipitation particles sweeping along the fuselage entered the opening and caused the damage.

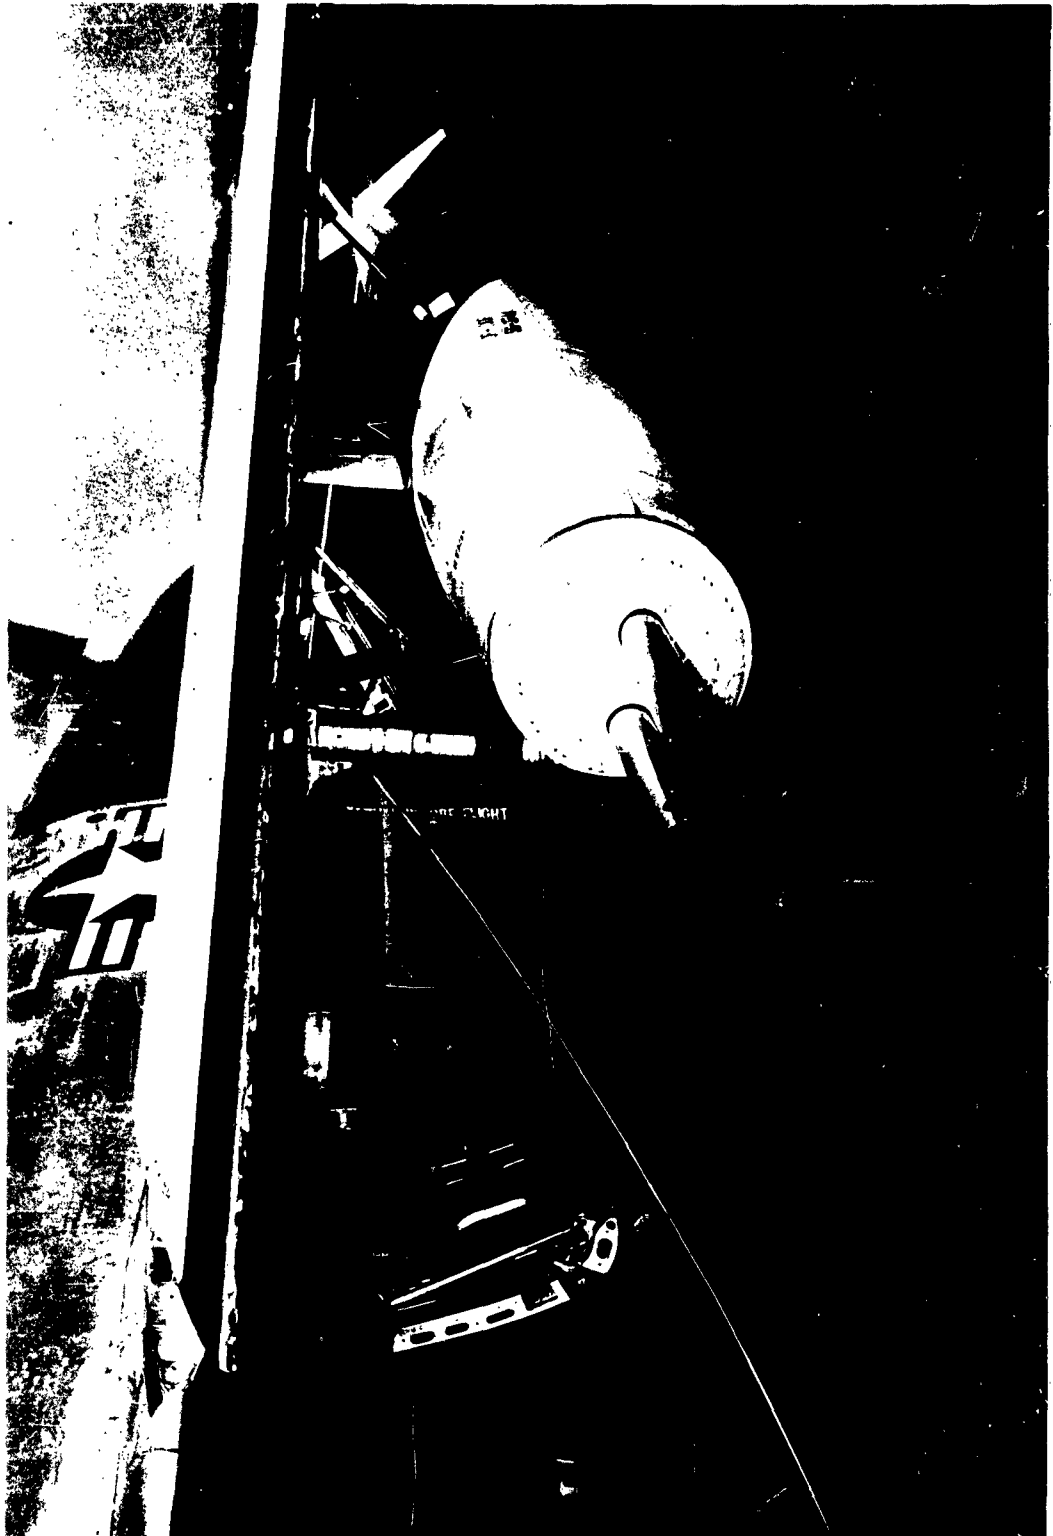
Figure 16. Cloud Particle Camera Mounted on F-100

The camera for photographing cloud particles is shown mounted on the F-100 in figure 16 and on the T-33 in figure 1. Figure 17 is a schematic of the system, while figure 18 shows the camera and its components. The camera was carried in a modified external fuel tank on the F-100 and in a modified chaff dispenser tank on the T-33. Both tanks were pressurized to maintain the internal pressure at or below 8000 feet to protect the high voltage components.

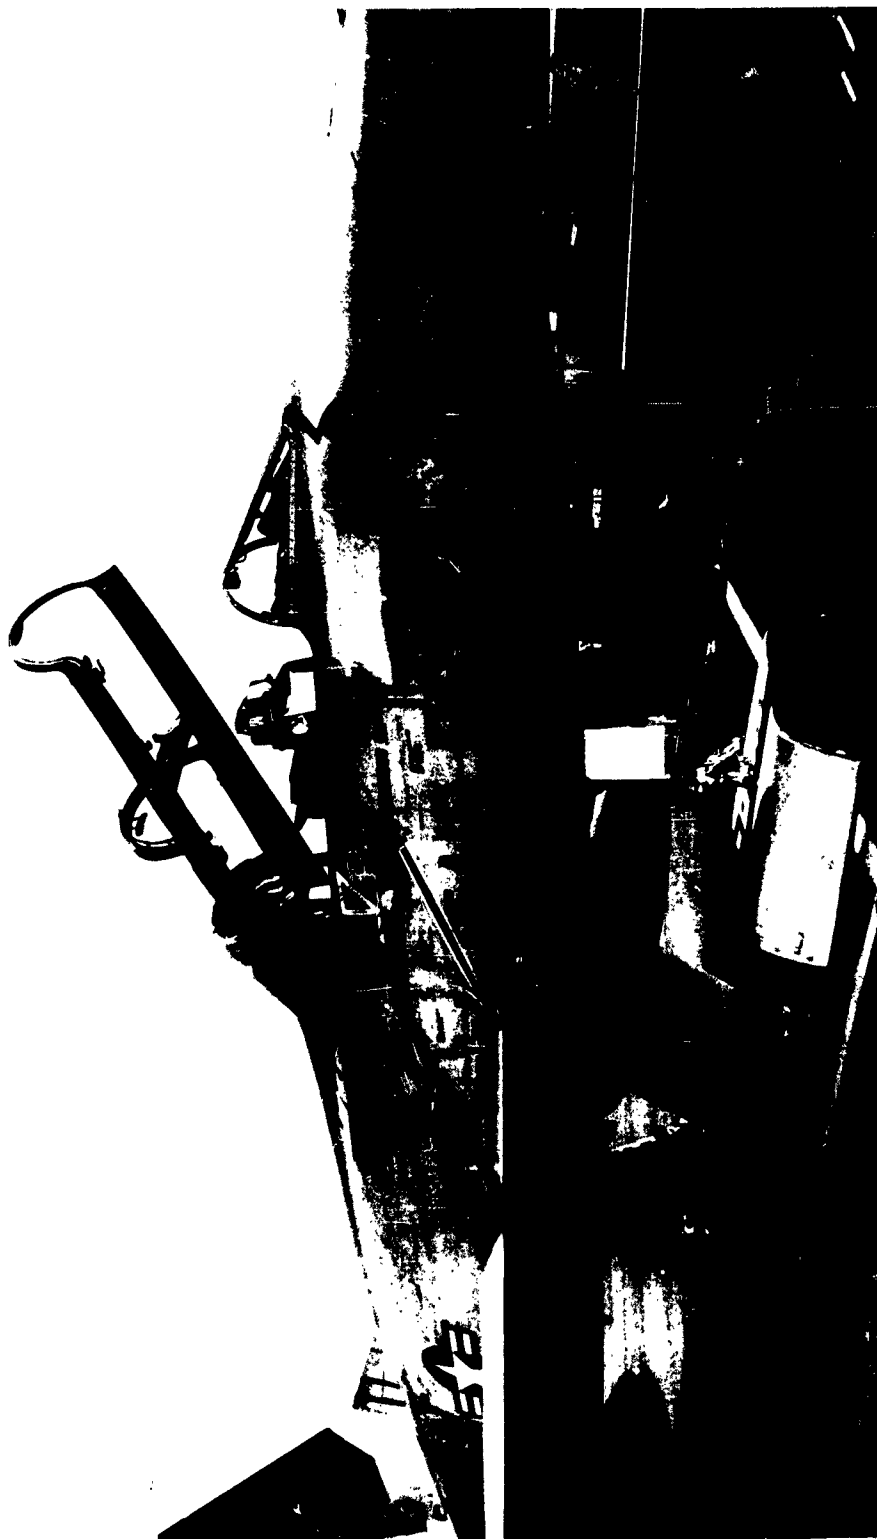
Figure 21. Right External Tank and Hail Camera, F-100

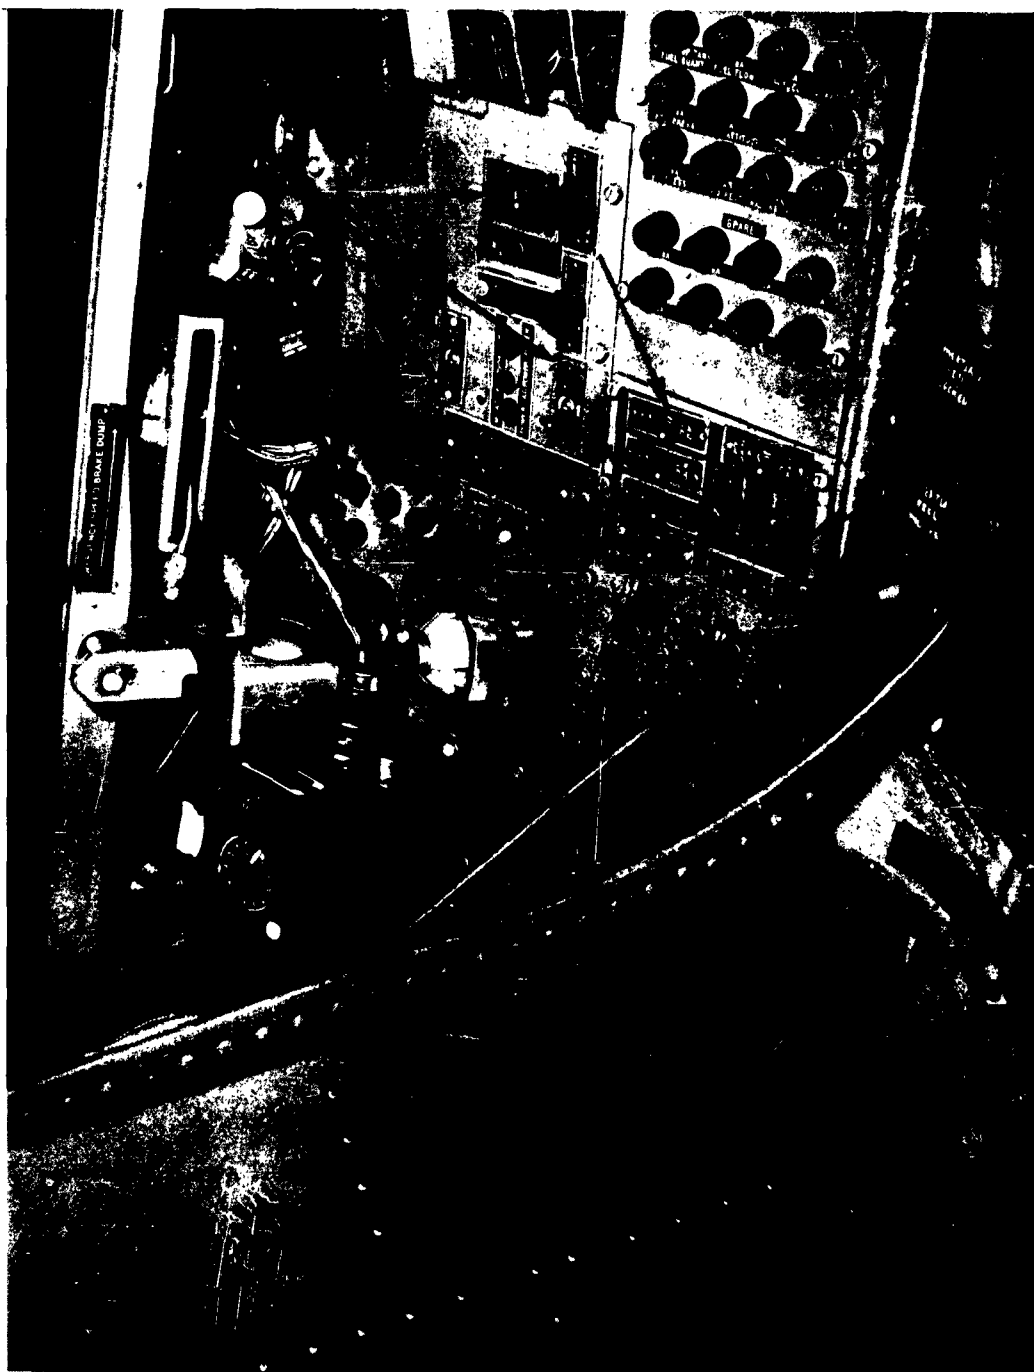
Figure 26. Test Instrumentation Controls on Left-Hand Console in Rear Seat of F-100

Figure 26 shows the instrument operator's control panel in the rear seat of the F-100. Figure 27 shows the indicator and selector switch for monitoring temperatures in the water vapor analyzer sample handling system (Item A) and the balance potentiometer and indicators for the electric field gear (Item B). The control panel for the T-33 pilot is shown in figure 28. Controls for the on-board tape recorder were on the opposite side of the cockpit. The control box for the differential pressure device is shown in figure 29. The needle in the box was not used in the test operating mode.

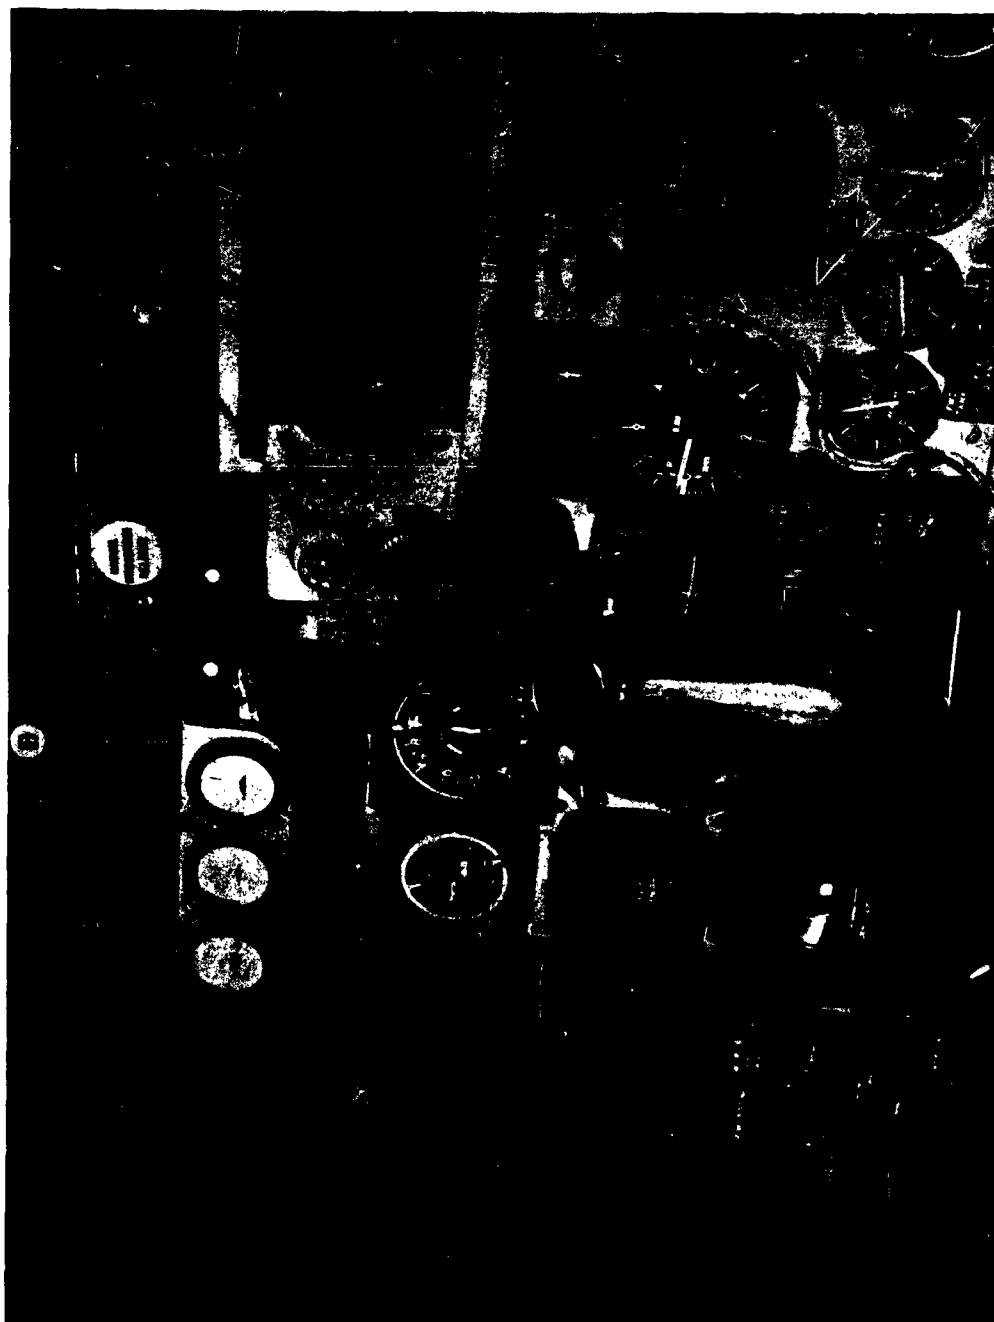
Figure 27. Test Instrumentation Control on Flight Instrument Panel, F-100

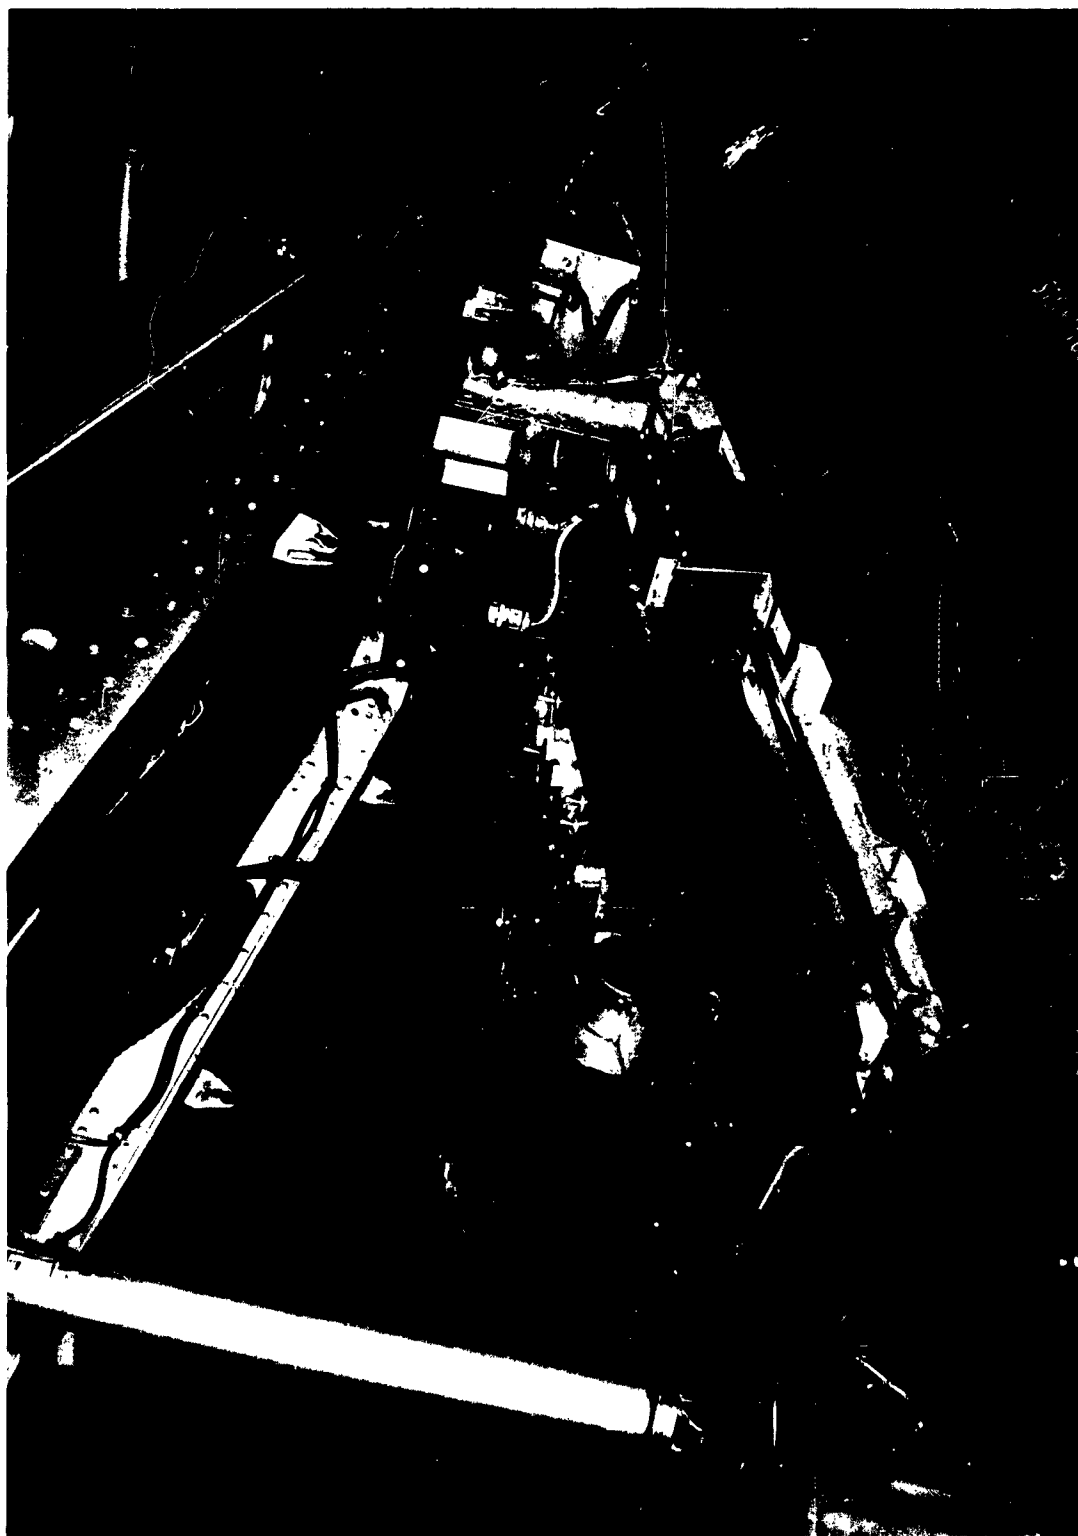
Figure 30. Oscillograph in T-33

What could be seen of the instrumentation in the back seat of the T-33 is illustrated by the oscillograph shown in figure 30. The oscillograph on the F-100 aircraft was in the nose compartment (figure 31).

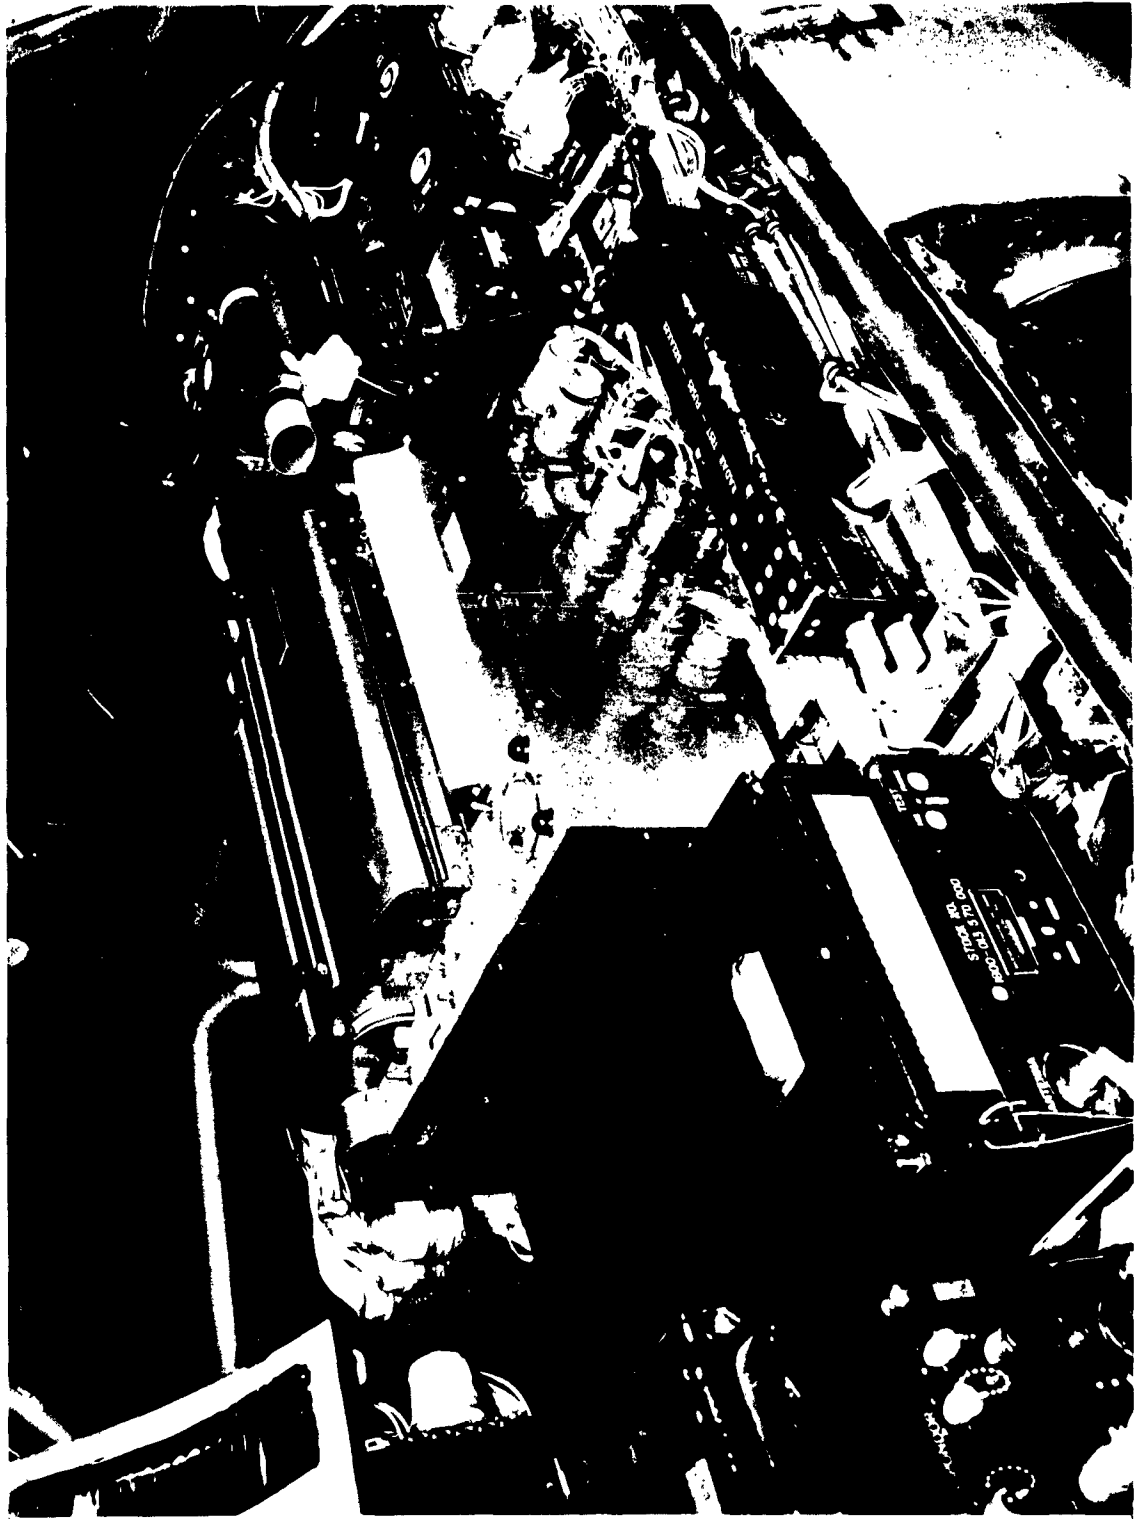
Figure 31. Oscillograph in F-100

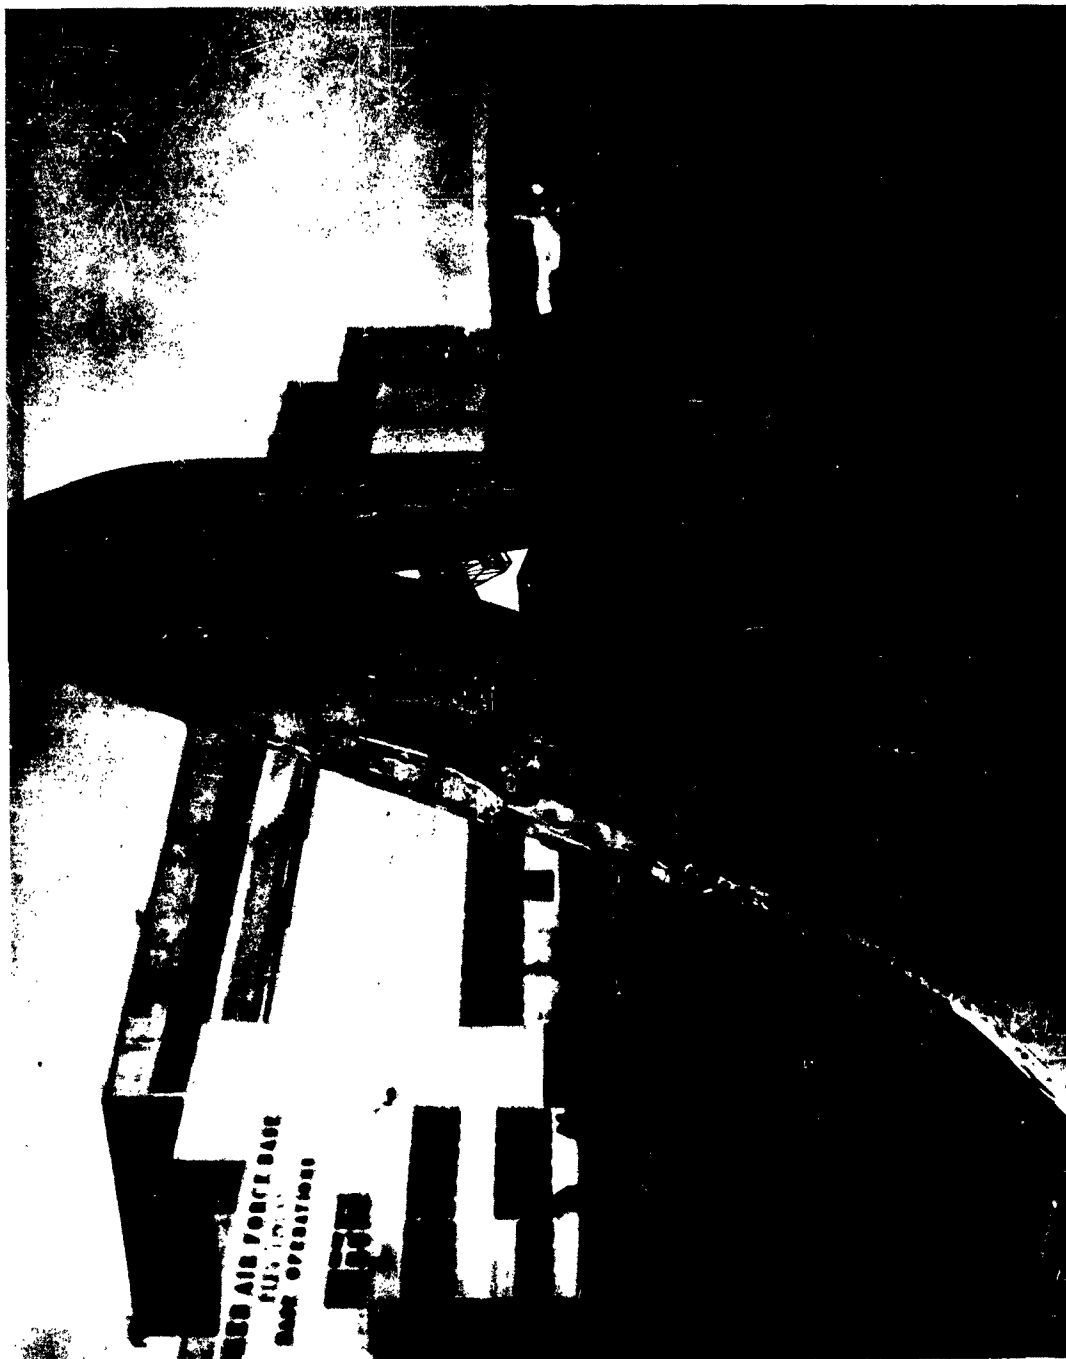
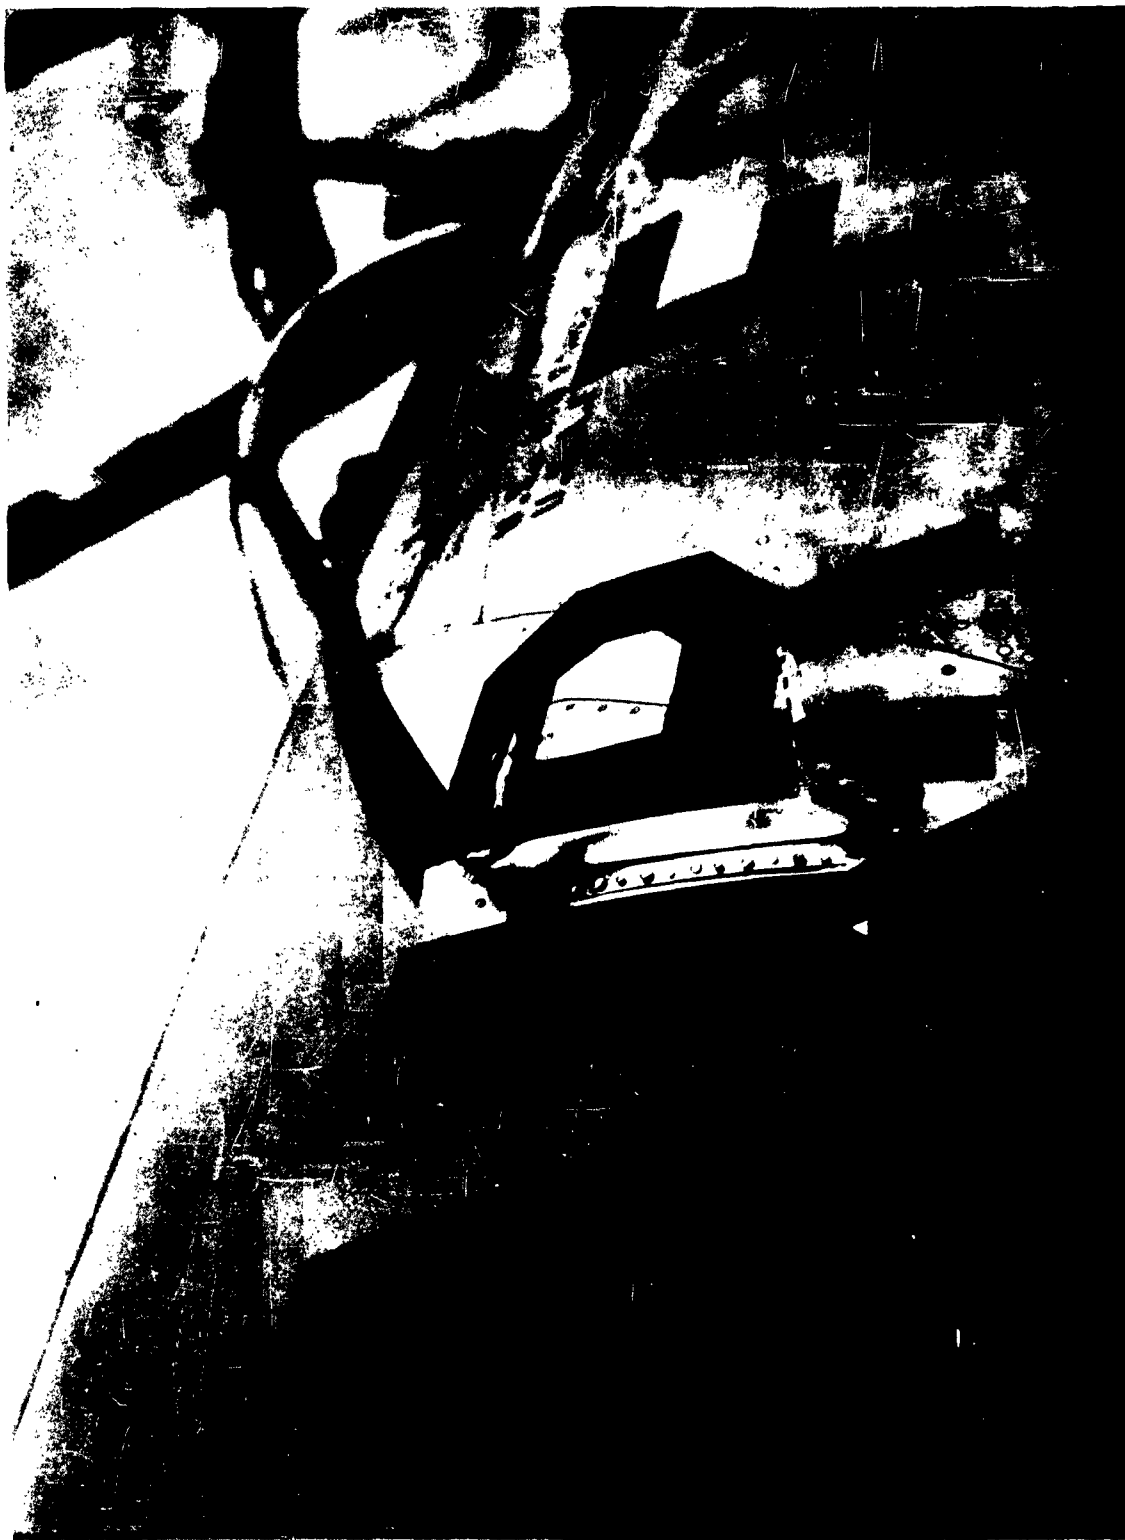
Figure 33. Damaged Antenna Covering on Nose of T-33

Figure 34. Damaged Left Intake Duct of T-33

Figure 35. Damaged Vertical Fin of T-33

Figure 36. Damaged Tip Tank of T-33

Figure 37. Damaged Louver on Left Fuselage of T-33

The T-33 was particularly susceptible to hail damage because of the soft metal used on much of the aircraft, straight wings, and blunt-nosed tip tanks. Figures 33, 34, 35, 36, and 37 show typical hail damage to the T-33. The vertical fin and antenna covering damage occurred during one flight (figures 33 and 35). Note the holes torn in the intake duct leading edge in figure 34. It was interesting to observe that the cooling louver on the left side of the T-33 (figure 37) was repaired/replaced three times, while the one on the right side did not sustain any damage at all.

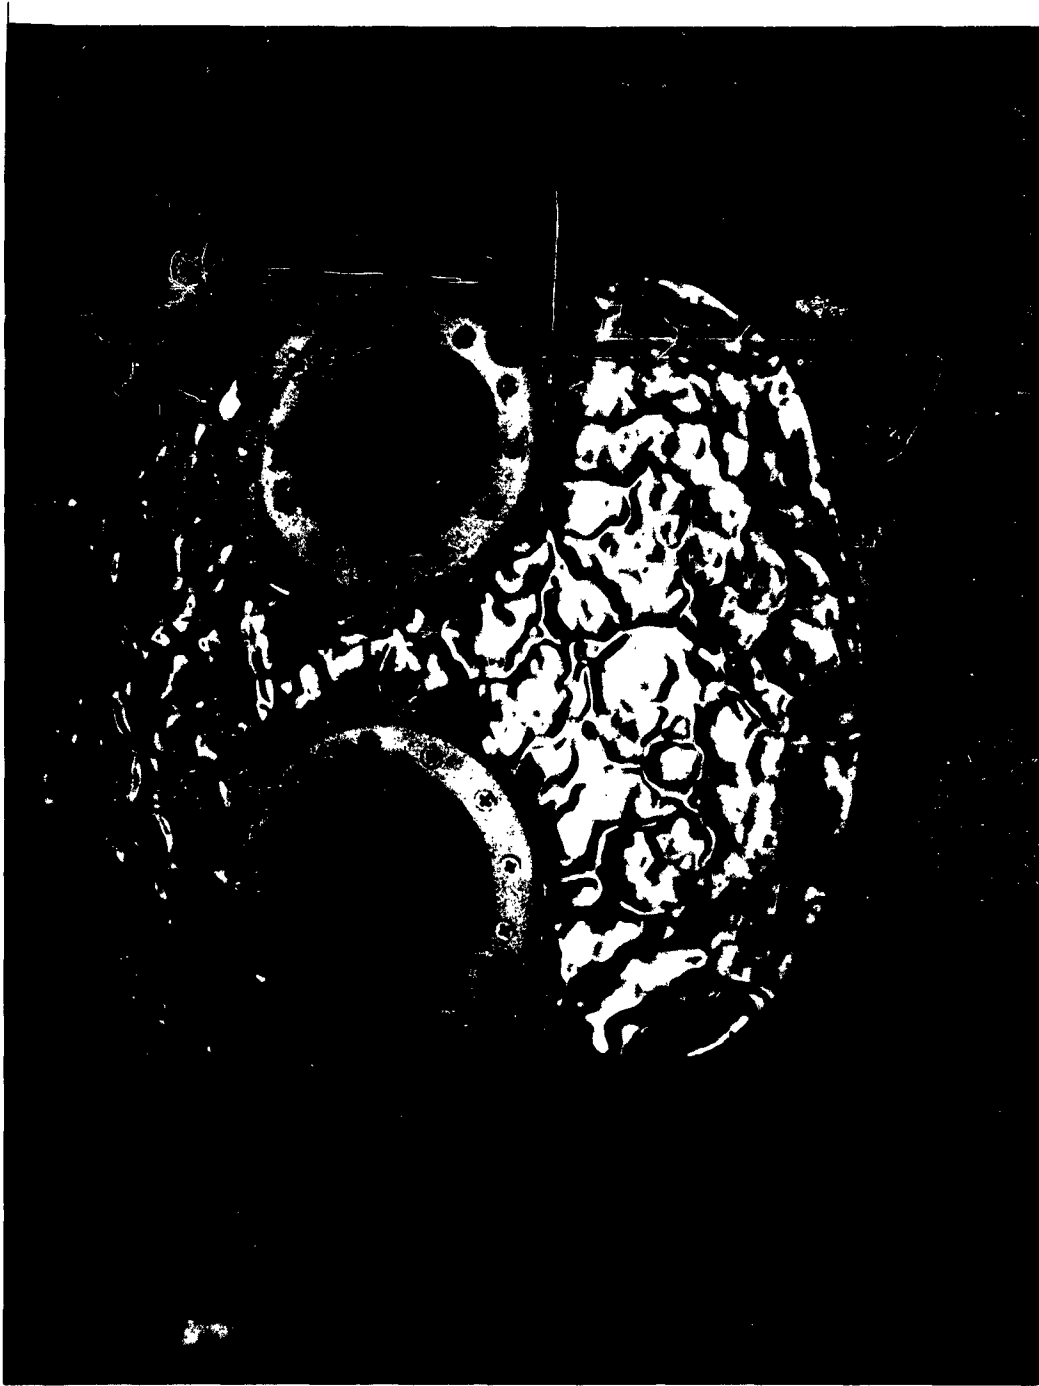
Figure 40. Damaged Sheet Metal Covering on Nose Fairing of Cloud Particle Camera

The nose fairings on the cloud particle camera tanks were constructed of wood. Ice crystal, rain, and hail erosion eventually called for a protective covering. The sheet metal first used was unsatisfactory, figure 40, and stainless steel replaced it, figure 41.

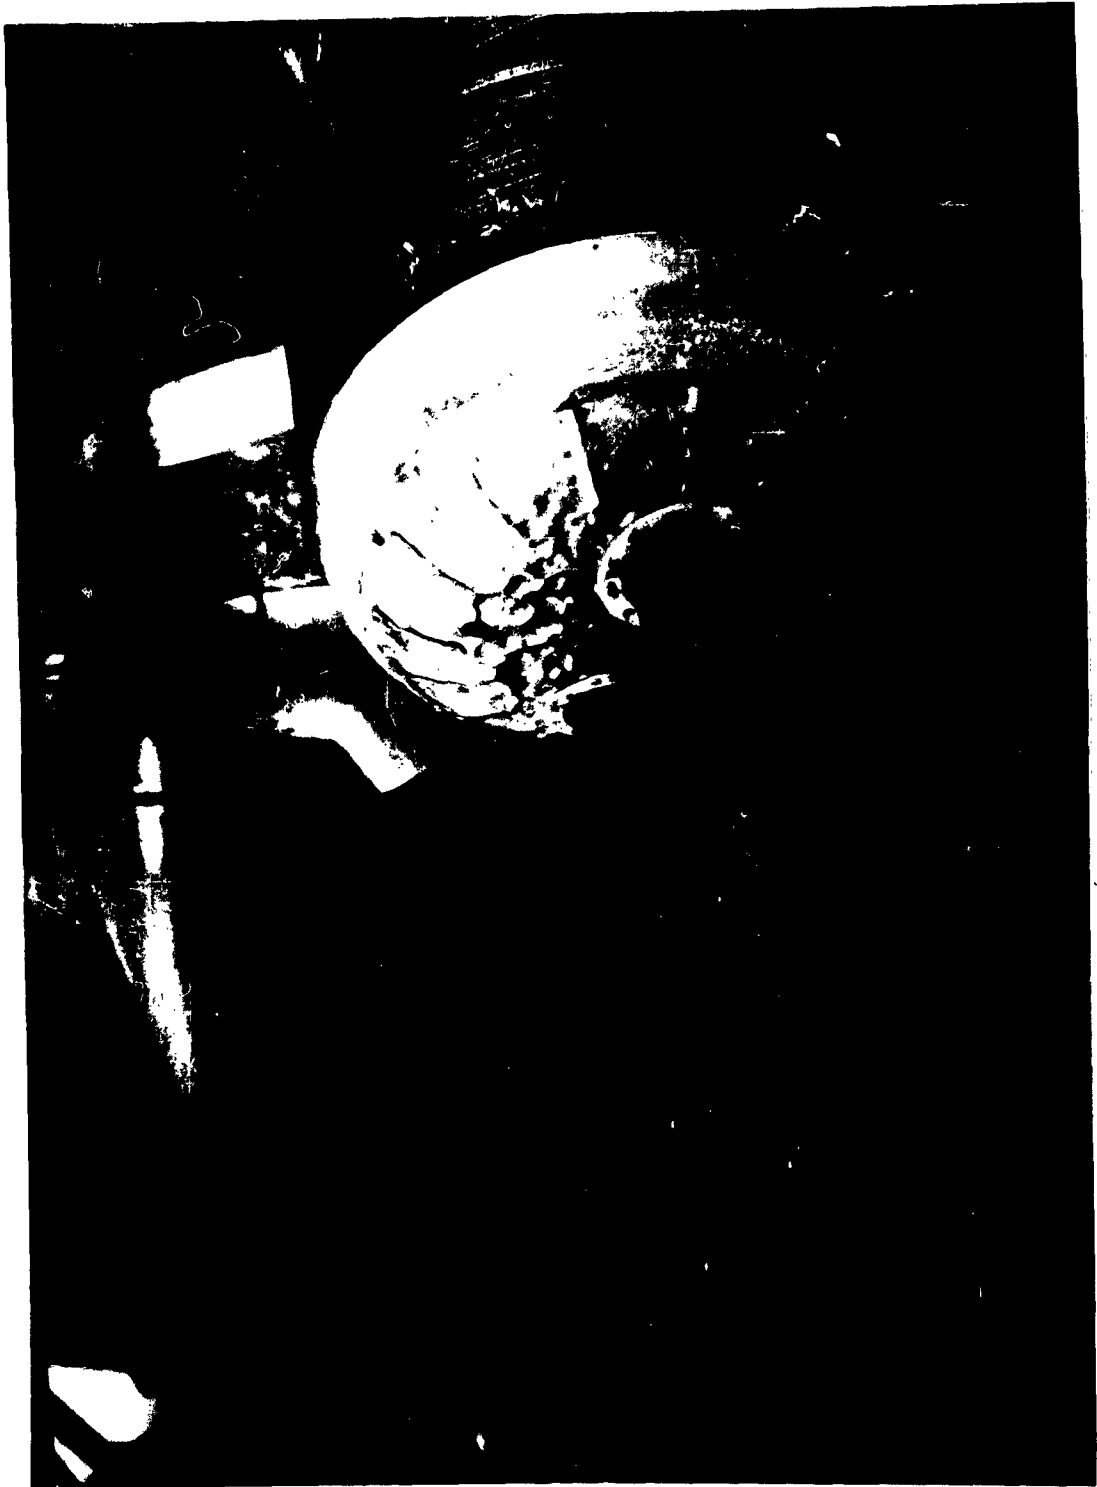
Figure 41. Stainless Steel Covering on Nose Fairing of Cloud Particle Camera
